All Saints, Boyne Hill, Maidenhead

EXTENSION OF THE CHANCEL

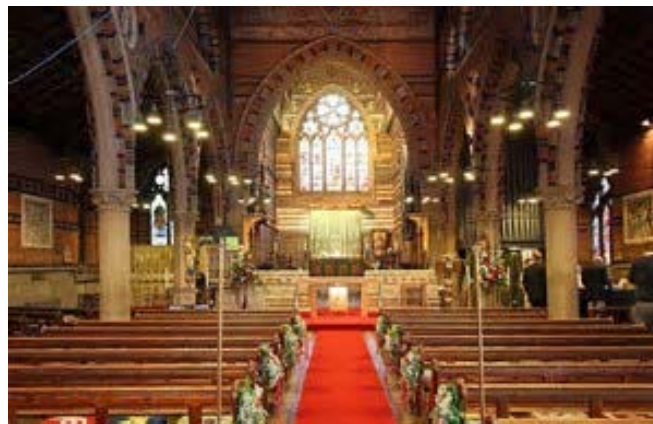
Fig 1 The interior of All Saints looking towards the chancel

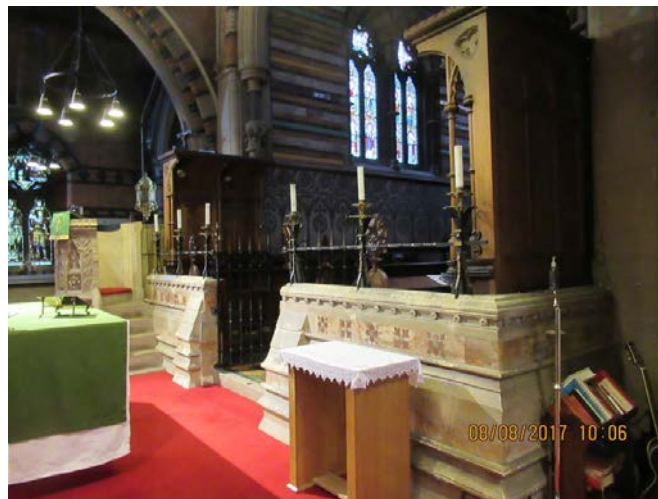
Fig 2 The dwarf wall separating the chancel from the nave

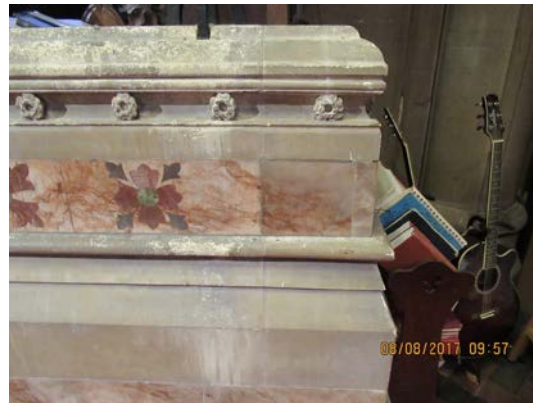
The dwarf wall The wall presents as a homogenous whole. However, If one looks carefully at either end of the wall it is noticeable that the marble tile is a slightly darker shade than the remaining tiles, and at the point there is a vertical join from top to bottom of the wall at both the south and the north ends. One could infer therefore that the wall may have been shorter by this amount, allowing it to have fitted inside the columns of the chancel arch, whilst the central opening with its gates remained the same size.

Fig 3 the south end of the wall

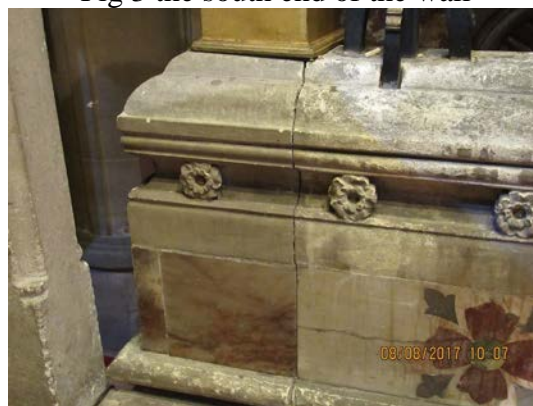
Fig 4 The north end of the wall

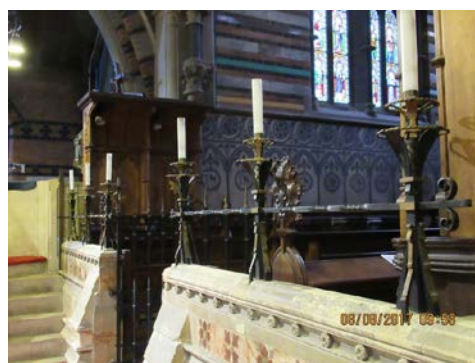
The wrought ironwork. On top of the wall there is an ornate rail constructed by James Leaver, a local man renowned for his artistry, much used by Street, and a churchwarden of All Saints. See figure 5. At first glance, the rails would be too large to go between the columns. However, it is quite possible for the horizontal finial on the South side to have been added later, as could the bar on the north side, whose scroll appears different from the others. Figures 6 and 7.

Fig 5 Leaver's ironwork rail

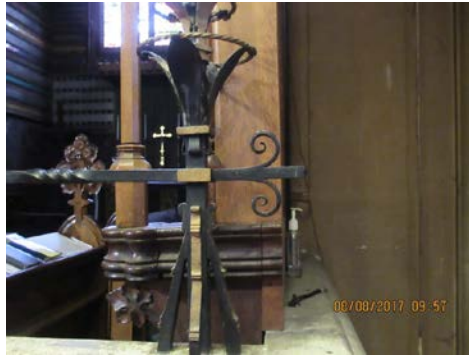
Fig 6 Wrought iron rail – horizontal finial at south end

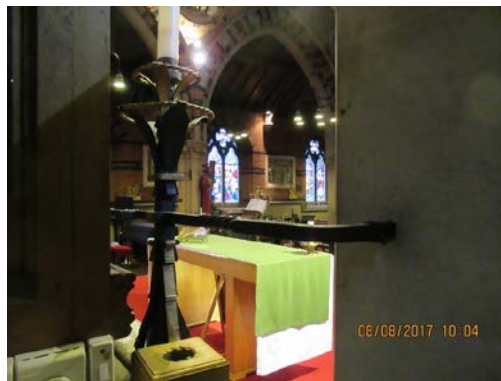
Fig 7 Wrought iron rail – horizontal bar and scroll at north end

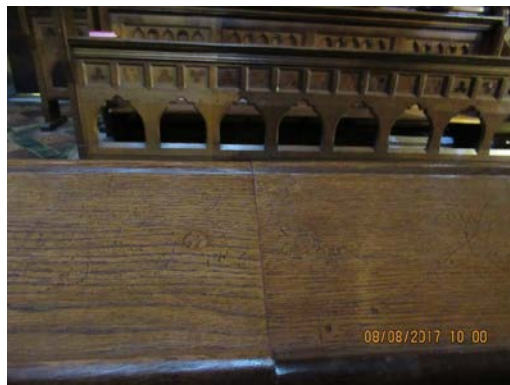
The choir stalls. There is evidence that the stalls have been extended at the eastern end albeit with the same level of skill which went into the construction of the original. A join can be seen about three feet in on both sides, and the wood, although oak again, is of a slightly lighter colour, actually more obvious in a photograph than in situ. Both these features can be seen in figure 8.

Fig 8 The join in the choir stalls and the different colour wood.

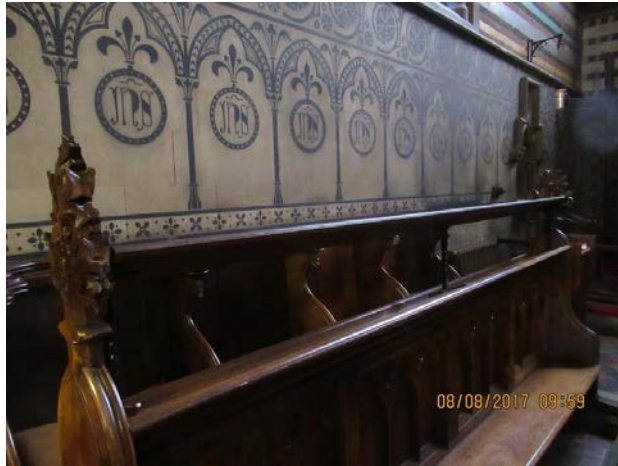
The extension to the backs of the misericord stalls have been carried out in a more complicated manner but nevertheless the joins can be seen. The book rests on the back stalls, figure 9, have no joins. This is because they were not included in Street's design, as can be seen in old photographs, but were added later presumably when the chancel extension was carried out.

Fig 9 Book rest

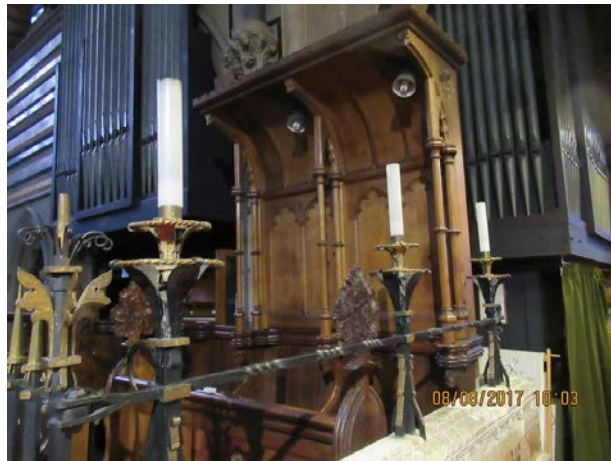
Choir stall canopies. Figure 10. The canopies, on both sides, are where the clergy sit. These were not part of Street's design, as, again, they do not appear in early photographs, and would not have fitted into place anyway.

Fig 10 Priest's canopy

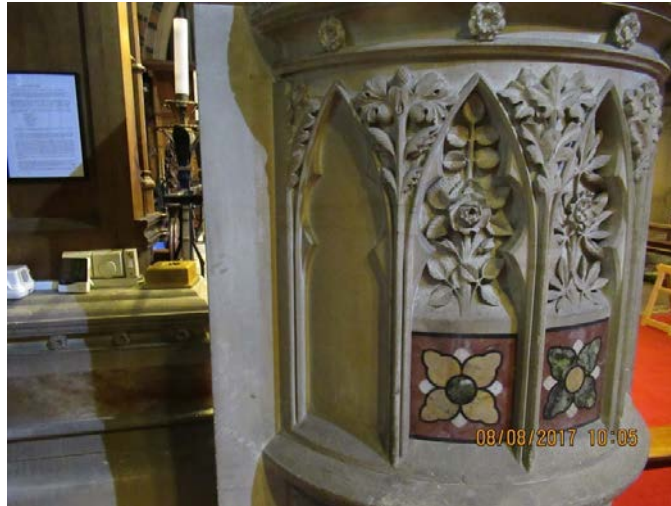
The pulpit. Street's plan and early photographs show that the pulpit was against the column of the chancel arch and has since been brought forward. Two clues to the original placement are to be seen. Firstly, to the back of the pulpit where it cannot be easily seen even now one of the decorative arched panels is blank – see figure 12. This panel would have been closer to the column originally and almost unseen.

Fig 12 The blank panel on the pulpit
